**Flood Control Project Maintenance
Levee Inspections**

Maintenance Issue Types Only, Levee Inspection Report By Mile - Spring 2019

Reclamation District No. 0010 Honcut

Waterway	Bank	Unit Miles	Inspection Start/End	Inspector
Unit No. 01 Simmerly Slough	Right	7.65	05/16/2019 05/16/2019	Sterling York

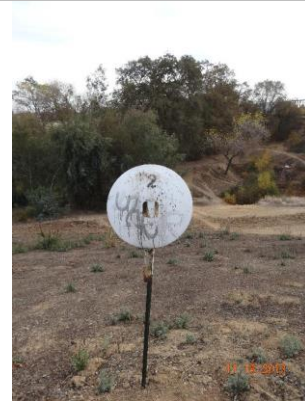
Photo 1 of 3 : UCIP_SP_2019_50058_51415.jpg

View of WS--Marker indicates crossing is labelled as 2.

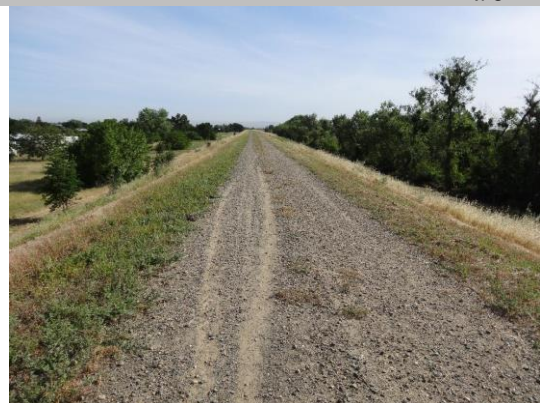
Photo 2 of 3 : UCIP_SP_2019_50058_51410.jpg

View of levee crown looking downstream.

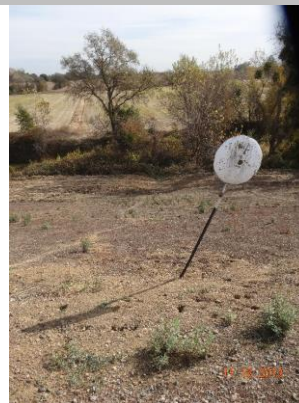
Photo 1 of 3 : UCIP_SP_2019_27748_51453.jpg

Comment Code					
Inspector Comment					
FS_ID:27748					
DS_ID:21261					
EP_NO: N/A					
Repair Type: No Action Needed					
Crossing Status: Found					
UCIP Comments: 04/29/2013 No signs of damage to levee present during inspection. This crossing is referenced in the USACE Periodic Inspection as item USACE_CESPK_HON1_2013_p_0037 and 0040. (DWR UCIP - O. Magana)					
FIELD_STRUCT_DESC: 24-inch corrugated metal gravity drainage pipe through the levee, 29.5 feet below the crown. Two corrugated metal cutoff walls around the pipe on each end. Slide gate on the landside (LS) end. Flap gate on the waterside (WS) end. Concrete headwall at the LS toe. [Additional Reference(s): DWR Levee Log, 2005. USACE Sacramento O&M Manual 151, May 1953, (Station 37+66)].					
FS Date: 4/29/2013

View of waterward side--slope and marker for pipe crossing.

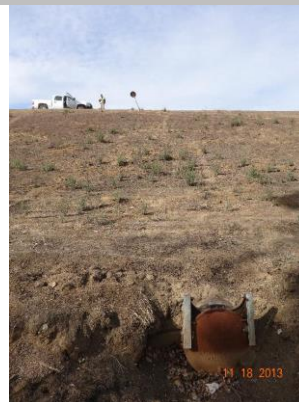
Photo 2 of 3 : UCIP_SP_2019_27748_51450.jpg

View of slope located on waterward side.

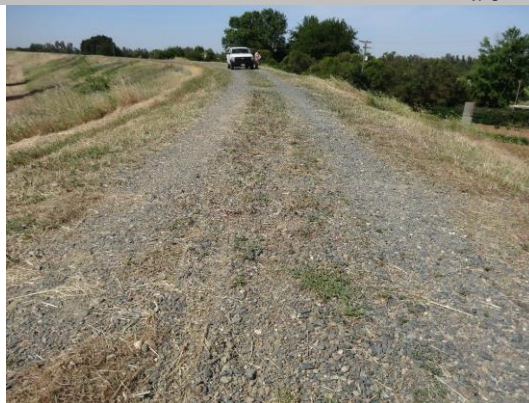
Photo 1 of 3 : UCIP_SP_2019_24811_44582.jpg

FS_ID:24811
DS_ID:21264
EP_NO: N/A
Repair Type: No Action Needed
Crossing Status: Found
UCIP Comments: 04/29/2013 This crossing is referenced in the USACE Periodic Inspection as item USACE_CESPK_HON1_2013_p_0004. (DWR UCIP - O. Magana)
FIELD_STRUCT_DESC: [Reclamation District No. 10 (RD0010) Drainage Plant] 16-inch steel drainage discharge pipe through the levee, 7 feet below the crown. Steel cutoff plate around the pipe at the center of the levee. Siphon breaker on the landside (LS) slope. Flap gate on the waterside (WS) end. Pump in a pit at the LS toe with steps along the LS slope. Saddle and 8-foot splash apron at the discharge end of the pipe. Concrete headwall at the LS toe. Metal shed on the LS slope. [Additional Reference(s): DWR Levee Log, 2005. USACE Sacramento O&M Manual 151, May 1953, (Station 13+88)].
FS Date: 4/29/2013

View of levee crown looking upstream of crossing.

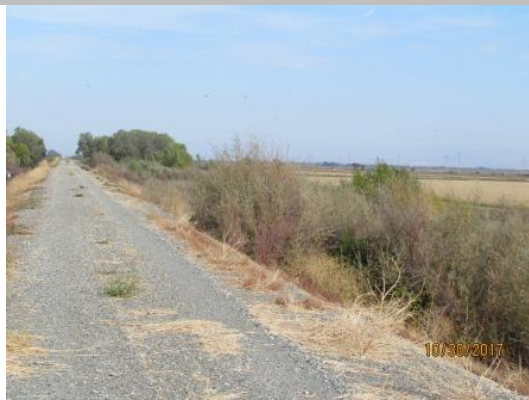
Photo 1 of 1 : SP_2019_RD0010_163_35_20190305_00002.jpg

LM Start	2.70	Rating **	M	Issue No.	35
LM End	2.70	Issue Type +	Ma	Location *	WS
Category	Earthen Levee			GPS Latitude/Longitude	
				Start	End
Item	Trim / Thin Trees			39.184974 °	39.184974 °
				-121.583836 °	-121.583836 °
DWR ID	DWR_RD0010_01_f_2017_35				
Comment Code					
T2 : Thin trees to allow visibility of the ground and room to flood fight.					
Inspector Comment					
Willows on levee slope need to be removed, Spring 2019.

View looking upstream waterside at Willow Trees that need to be removed.

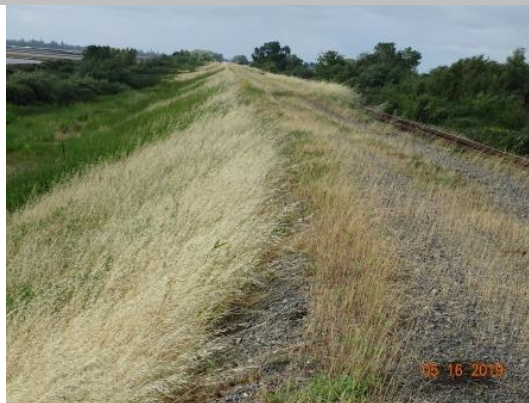
Photo 1 of 1 : SP_2019_RD0010_163_28_20190520_00082.jpg

LM Start	3.63	Rating **	M	Issue No.	28
LM End	5.10	Issue Type +	Ma	Location *	CR
Category	Earthen Levee			GPS Latitude/Longitude	
				Start	End
Item	Vegetation			39.198307 °	39.219462 °
				-121.582151 °	-121.579535 °
DWR ID	DWR_RD0010_01_s_2019_28				
Comment Code					
V1 : Control annual grass and weeds on the levee slopes and easements.					
Inspector Comment					
Annual vegetation needs to be maintained on the crown and slopes, Spring 2019.

View looking downstream crown at the annual vegetation that needs to be maintained, Spring 2019.

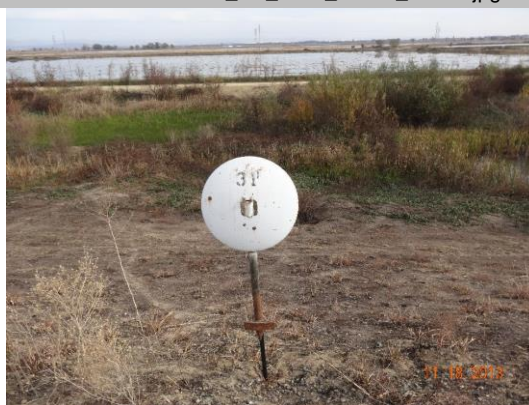
Photo 1 of 3 : UCIP_SP_2019_27746_51436.jpg

Comment Code					
Inspector Comment					
FS_ID:27746					
DS_ID:21273					
EP_NO: N/A					
Repair Type: No Action Needed					
Crossing Status: Found					
UCIP Comments: 04/29/2013 This crossing is referenced in the					
USACE Periodic Inspection as item					
USACE_CESPK_HON1_2013_p_0217. (DWR UCIP - O. Magana)					
FIELD_STRUCT_DESC: 24-inch reinforced concrete gravity drainage					
pipe through the levee, 19.5 feet below the crown. Flap gate on the					
waterside (WS) end. Concrete headwall at each toe. Concrete saddle					
and apron on the WS. [Additional Reference(s): DWR Levee Log, 2005.					
USACE Sacramento O&M Manual 151, May 1953, (Station 317+80)].					
FS Date: 4/29/2013

View of waterward side--marker for pipe visible on waterward shoulder.

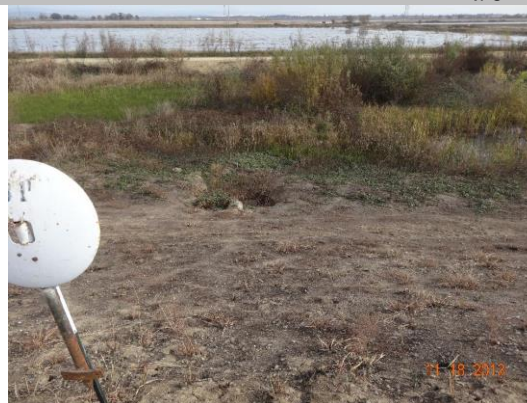
Photo 2 of 3 : UCIP_SP_2019_27746_51435.jpg

View of pipe on waterward toe.

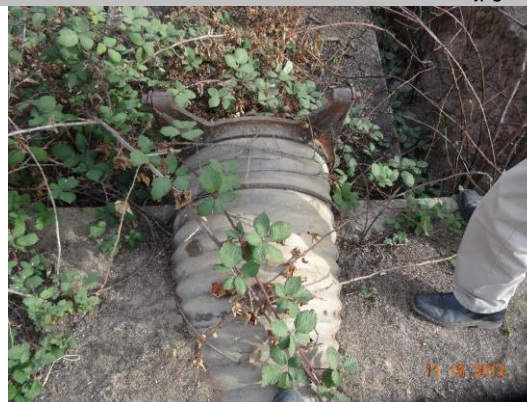
Photo 3 of 3 : UCIP_SP_2019_27746_51439.jpg

View of pipe, headwall, and concrete apron on waterward toe.

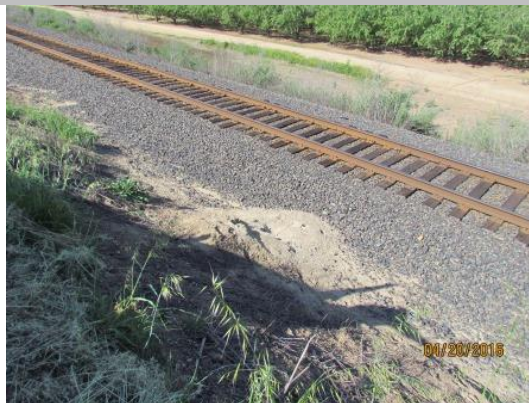
Photo 1 of 1 : SP_2019_RD0010_163_51_20190305_00012.jpg

LM Start	3.75	Rating **	U	Issue No.	51
LM End	3.75	Issue Type +	Ma	Location *	LS
Category	Earthen Levee			GPS Latitude/Longitude	
				Start	End
Item	Animal Control			39.200003 °	39.200003 °
				-121.582002 °	-121.582002 °
DWR ID	DWR_RD0010_01_s_2016_51				
Comment Code					
A3 : No rodents visible, but rodent burrows visible; need to backfill and compact or grout burrows.					
Inspector Comment					
There is a large rodent hole the exceeds 2 cubic feet of dirt and needs to be properly backfilled. Spring 2019.

View of large burrow on landside.

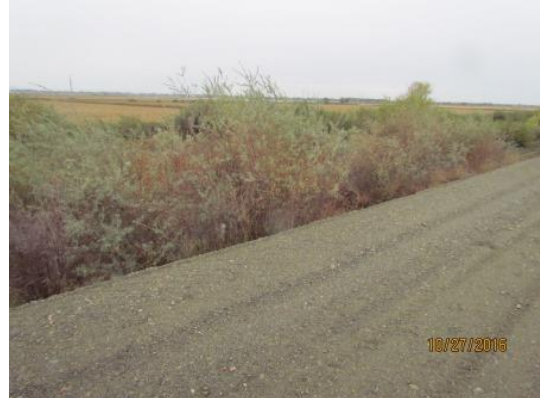
Photo 1 of 1 : SP_2019_RD0010_163_49_20190305_00010.jpg

LM Start	3.93	Rating **	M	Issue No.	49
LM End	3.93	Issue Type +	Ma	Location *	WS
Category	Earthen Levee			GPS Latitude/Longitude	
				Start	End
Item	Trim / Thin Trees			39.202570 °	39.202570 °
				-121.581681 °	-121.581681 °
DWR ID	DWR_RD0010_01_s_2016_49				
Comment Code					
T2 : Thin trees to allow visibility of the ground and room to flood fight.					
Inspector Comment					
Remove small willow trees from the levee slope. Spring 2019.

View of small starter willow trees on the landside looking upstream.

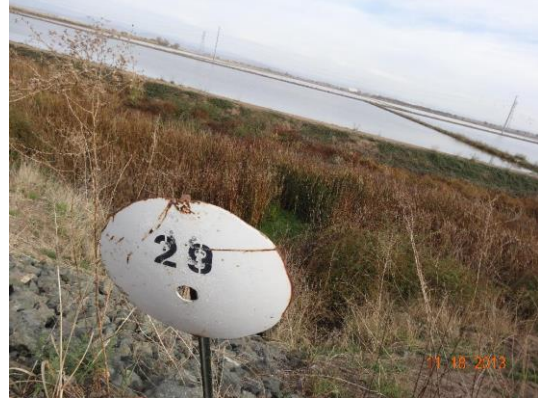
Photo 1 of 3 : UCIP_SP_2019_53138_44811.jpg

UCIP Comments: 10/18/2018 According to the LMA representative, a small pipe repair was completed near the WS gate (pipe was leaking at pipe collar). Pipe has been upgraded from Non-Urgent to Urgent due to the wall deterioration near the outlet and an unknown condition through the levee. Levee is about 20 feet high. Recommend video inspection to determine pipe condition through the levee. This pipe is part of DWR's Deferred Maintenance Project (DMP), video inspection is expected to be completed next year for this crossing. (O. Magana - DWR UCIP)7/01/2016 WS slope appears to be stable; UCIP issue has been downgraded from Urgent to Non-Urgent due to what appears to be a stable slope--no other issues were observed during the site visit. The reason for the Non-Urgent classification is due to the limited documentation available to support extent of repair--need to obtain repair records to determine extent of repair and to determine if pipe was replaced through the levee. (DWR UCIP - omagana)4/29/2013 limited access; steep slopes, and dense vegetation; New riprap has been placed along pipe alignment need to contact owner to determine work authorization. Also need to find out if the design for riprap was due to slope failure at this location. This crossing is referenced in the USACE Periodic Inspection as item USACE_CESPK_HON1_2013_p_0246. (DWR UCIP - omagana)

Marker for pipe crossing visible on WS shoulder.

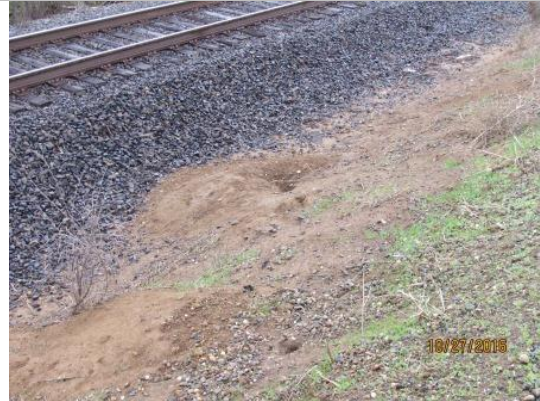
Photo 1 of 1 : SP_2019_RD0010_163_42_20190305_00006.jpg

LM Start	5.04	Rating **	M	Issue No.	42
LM End	5.04	Issue Type +	Ma	Location *	LS
Category	Earthen Levee			GPS Latitude/Longitude	
				Start	End
Item	Animal Control			39.218564 °	39.218564 °
				-121.579682 °	-121.579682 °
DWR ID	DWR_RD0010_01_s_2016_42				
Comment Code					
A3 : No rodents visible, but rodent burrows visible; need to backfill and compact or grout burrows.					
Inspector Comment					
Squirrel holes still are visible but there is no sign of activity, Spring 2019.

View of squirrel holes on landside toe, no sign of activity.

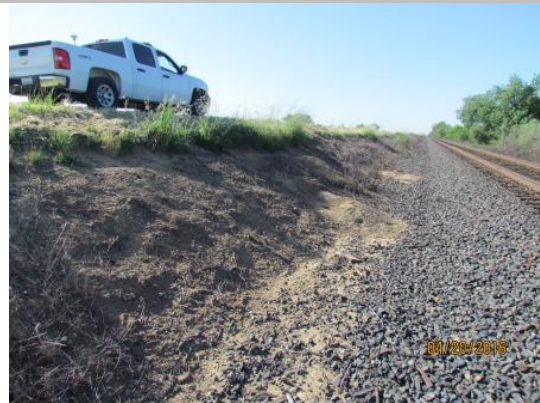
Photo 1 of 1 : SP_2019_RD0010_163_41_20190305_00005.jpg

LM Start	5.45	Rating **	M	Issue No.	41
LM End	5.45	Issue Type +	Ma	Location *	LS
Category	Earthen Levee			GPS Latitude/Longitude	
				Start	End
Item	Animal Control			39.224485 °	39.224485 °
				-121.578944 °	-121.578944 °
DWR ID	DWR_RD0010_01_s_2016_41				
Comment Code					
A3 : No rodents visible, but rodent burrows visible; need to backfill and compact or grout burrows.					
Inspector Comment					
Squirrel holes still are visible but there is no sign of activity, Spring 2019.

View of multiple ground squirrel holes on landside slope looking downstream. There is no evidences of active squirrels.

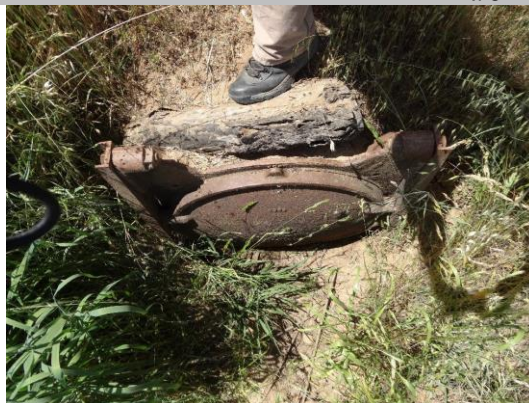
Photo 3 of 3 : UCIP_SP_2019_24438_43501.jpg

Comment Code						
Inspector Comment						
FS_ID:24438 DS_ID:21278 EP_NO: N/A Repair Type: Non-Urgent Crossing Status: Found UCIP Comments: 04/29/2013 Dense vegetation limits the inspector's visibility to identify signs of pipe failure (leaks) along the slope. Recommend removing vegetation along pipe alignment to conduct proper inspection of structure and appurtances. This crossing is referenced in the USACE Periodic Inspection as item USACE_CESPK_HON1_2013_p_0290. (DWR UCIP - O. Magana) FIELD_STRUCT_DESC: 30-inch corrugated metal gravity drainage pipe through the levee, 12.5 feet below the crown. Corrugated metal cutoff wall around the pipe at each shoulder. Flap gate on the waterside (WS) end. Concrete headwall, saddle, and apron on the WS end. [Additional Reference(s): DWR Levee Log, 2005. USACE Sacramento O&M Manual 151, May 1953, (Station 455+00)]. FS Date: 4/29/2013

Pipe and flap gate confirmed on waterward side.

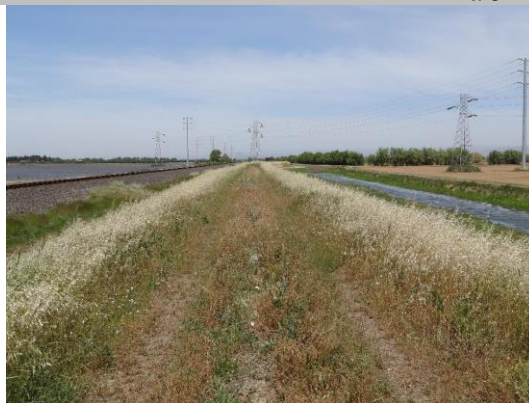
Photo 1 of 3 : UCIP_SP_2019_27532_51129.jpg

Comment Code					
Inspector Comment					
FS_ID:27532 DS_ID:21279 EP_NO: N/A Repair Type: Non-Urgent Crossing Status: Found UCIP Comments: 04/29/2013 Need to clear sediment near gate. Need to coordinate with owner to determine status of crossing. If crossing is no longer in use owner will need to contact the CVFPB to comply with Title 23. This crossing is referenced in the USACE Periodic Inspection as item USACE_CESPK_HON1_2013_p_0291-294. (DWR UCIP - O. Magana) FIELD_STRUCT_DESC: 16-inch steel drainage pipe through the levee, 10.3 feet below the crown. Cutoff wall around the pipe at the center of the levee. Slide gate on the waterside (WS) end. Pipe exposed across irrigation canal on the landside (LS). [Additional Reference(s): DWR Levee Log, 2005. USACE Sacramento O&M Manual 151, May 1953, (Station 473+58)]. FS Date: 4/29/2013

View of levee looking upstream.

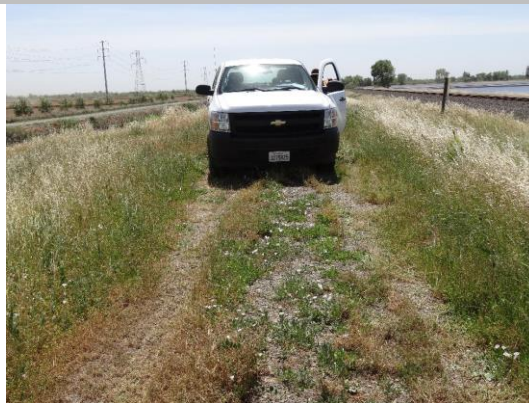
Photo 2 of 3 : UCIP_SP_2019_27532_51128.jpg

View of levee looking downstream.

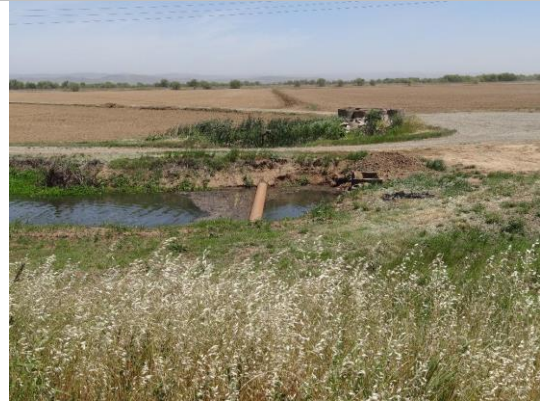
Photo 3 of 3 : UCIP_SP_2019_27532_51130.jpg

Comment Code					
Inspector Comment					
FS_ID:27532 DS_ID:21279 EP_NO: N/A Repair Type: Non-Urgent Crossing Status: Found UCIP Comments: 04/29/2013 Need to clear sediment near gate. Need to coordinate with owner to determine status of crossing. If crossing is no longer in use owner will need to contact the CVFPB to comply with Title 23. This crossing is referenced in the USACE Periodic Inspection as item USACE_CESPK_HON1_2013_p_0291-294. (DWR UCIP - O. Magana) FIELD_STRUCT_DESC: 16-inch steel drainage pipe through the levee, 10.3 feet below the crown. Cutoff wall around the pipe at the center of the levee. Slide gate on the waterside (WS) end. Pipe exposed across irrigation canal on the landside (LS). [Additional Reference(s): DWR Levee Log, 2005. USACE Sacramento O&M Manual 151, May 1953, (Station 473+58)]. FS Date: 4/29/2013

View of waterward side--pipe goes through Simmerly Slough.

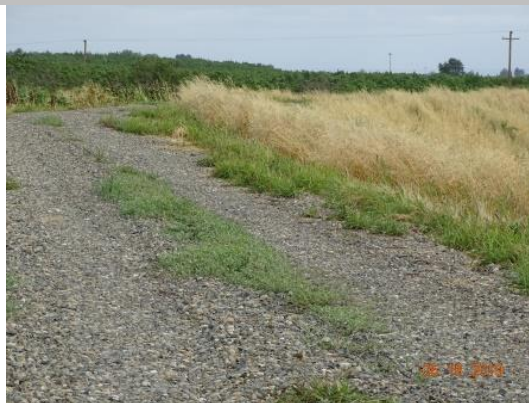
Photo 1 of 1 : SP_2019_RD0010_164_43_20190520_00101.jpg

LM Start	0.16	Rating **	M	Issue No.	43
LM End	8.02	Issue Type +	Ma	Location *	LS
Category	Earthen Levee			GPS Latitude/Longitude	
				Start	End
Item	Vegetation			39.166005 °	39.274333 °
				-121.610326 °	-121.612005 °
DWR ID	DWR_RD0010_02_s_2019_43				
Comment Code					
V1 : Control annual grass and weeds on the levee slopes and easements.					
Inspector Comment					
The annual vegetation needs to be maintained, Spring 2019.

View looking upstream landside at the annual vegetation that needs maintenance, Spring 2019.

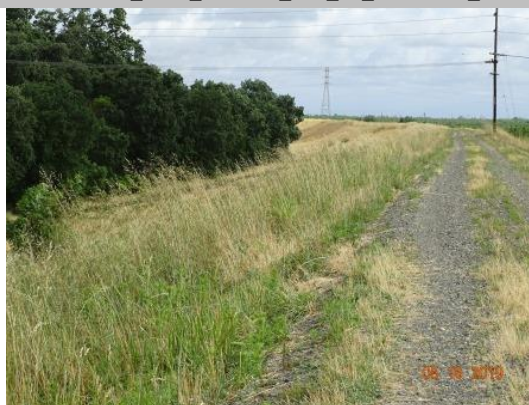
Photo 1 of 1 : SP_2019_RD0010_164_46_20190520_00100.jpg

LM Start	0.33	Rating **	M	Issue No.	46
LM End	8.02	Issue Type +	Ma	Location *	WS
Category	Earthen Levee			GPS Latitude/Longitude	
				Start	End
Item	Vegetation			39.168418 °	39.274334 °
				-121.610641 °	-121.612004 °
DWR ID	DWR_RD0010_02_s_2019_46				
Comment Code					
V1 : Control annual grass and weeds on the levee slopes and easements.					
Inspector Comment					
The annual vegetation needs to be maintained, Spring 2019.

View looking upstream waterside at the annual vegetation that needs maintenance, Spring 2019.

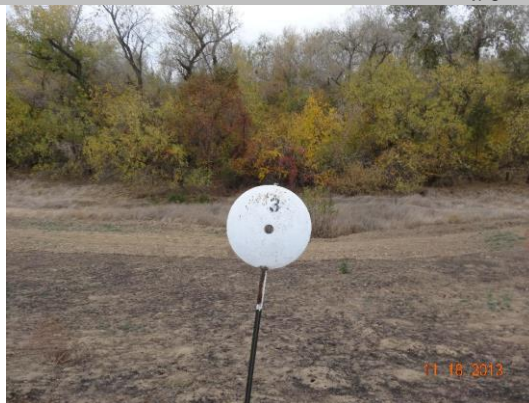
Photo 1 of 3 : UCIP_SP_2019_27533_51135.jpg

Comment Code					
Inspector Comment					
FS_ID:27533 DS_ID:21280 EP_NO: N/A Repair Type: Non-Urgent Crossing Status: Found UCIP Comments: 04/30/2013 Recommend removing vegetation and debris along pipe alignment (debris blocking gate on waterward side and vegetation blocking access to screw gate on landward side). Need to coordinate with owner to determine status of crossing. If crossing is no longer in use owner will need to contact the CVFPB to comply with Title 23. This crossing is referenced in the USACE Periodic Inspection as item USACE_CESPK_HON2_2013_p_0027. (DWR UCIP - O. Magana) FIELD_STRUCT_DESC: 24-inch corrugated metal gravity drainage pipe through the levee, 25.6 feet below the crown. Corrugated metal cutoff wall around the pipe at each shoulder. Flap gate on the waterside (WS) end. Concrete headwall, saddle, and apron on the WS end. [Additional Reference(s): DWR Levee Log, 2005. USACE Sacramento O&M Manual 151, May 1953, (Station 106+00)]. FS Date: 4/30/2013

View of waterward side.

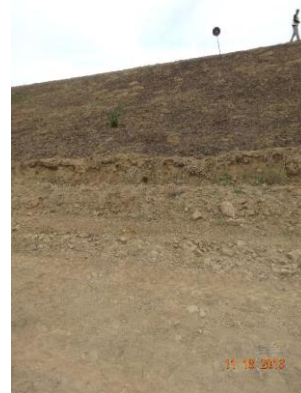
Photo 2 of 3 : UCIP_SP_2019_27533_51137.jpg

View of waterward slope.

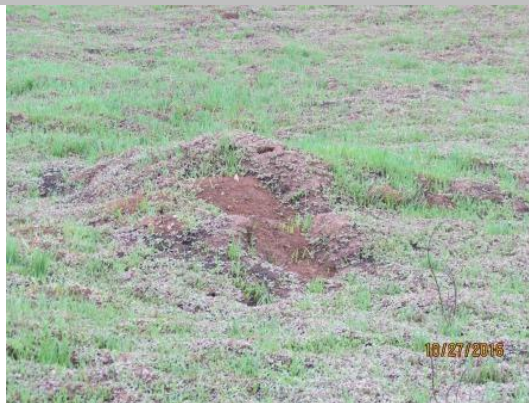
Photo 1 of 1 : SP_2019_RD0010_164_29_20190305_00004.jpg

LM Start	0.94	Rating **	U	Issue No.	29
LM End	0.94	Issue Type +	Ma	Location *	WS
Category	Earthen Levee			GPS Latitude/Longitude	
				Start	End
Item	Animal Control			39.177289 °	39.177289 °
				-121.609860 °	-121.609860 °
DWR ID	DWR_RD0010_02_f_2015_29				
Comment Code					
A3 : No rodents visible, but rodent burrows visible; need to backfill and compact or grout burrows.					
Inspector Comment					
No rodent activity but squirrel hole needs to be backfilled, Spring 2019.

View of rodent hole that has more than 2 cubic feet of material on the waterside.

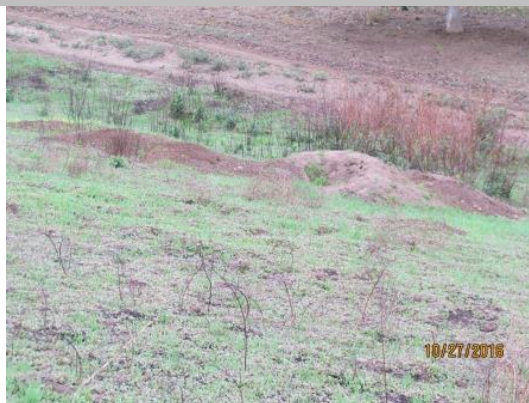
Photo 1 of 1 : SP_2019_RD0010_164_30_20190305_00005.jpg

LM Start	1.13	Rating **	U	Issue No.	30
LM End	1.13	Issue Type +	Ma	Location *	WS
Category	Earthen Levee			GPS Latitude/Longitude	
				Start	End
Item	Animal Control			39.179947 °	39.179947 °
				-121.610024 °	-121.610024 °
DWR ID	DWR_RD0010_02_f_2015_30				
Comment Code					
A3 : No rodents visible, but rodent burrows visible; need to backfill and compact or grout burrows.					
Inspector Comment					
No rodent activity but squirrel hole needs to be backfilled, Spring 2019.

View of rodent hole that has more than 2 cubic feet of material on the waterside.

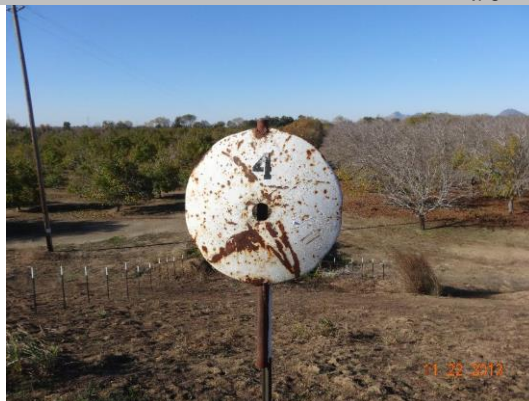
Photo 1 of 3 : UCIP_SP_2019_24821_44640.jpg

Comment Code					
Inspector Comment					
FS_ID:24821					
DS_ID:21281					
EP_NO: N/A					
Repair Type: Non-Urgent					
Crossing Status: Found					
UCIP Comments: 04/30/2013 Screw gate on landward side is blocked by sediment. Recommend removing sediment in front of gate. This crossing is referenced in the USACE Periodic Inspection as item USACE_CESPK_HON2_2013_p_0082. (DWR UCIP - O. Magana)					
FIELD_STRUCT_DESC: 24-inch corrugated metal gravity drainage pipe through the levee, 26 feet below the crown. Corrugated metal cutoff wall around the pipe at each shoulder. Flap gate on the waterside (WS) end. Slide gate on the landside (LS) end. Concrete headwall, saddle, and apron on the WS end. [Additional Reference(s): DWR Levee Log, 2005. USACE Sacramento O&M Manual 151, May 1953, (Station 149+88)].					
FS Date: 4/30/2013

Marker visible on waterward side--No. 4.

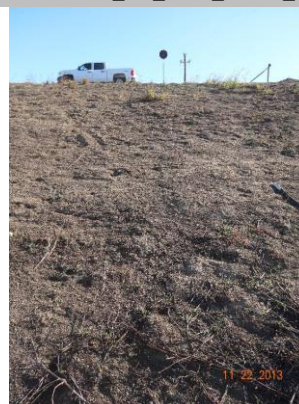
Photo 2 of 3 : UCIP_SP_2019_24821_44639.jpg

View of waterward slope side.

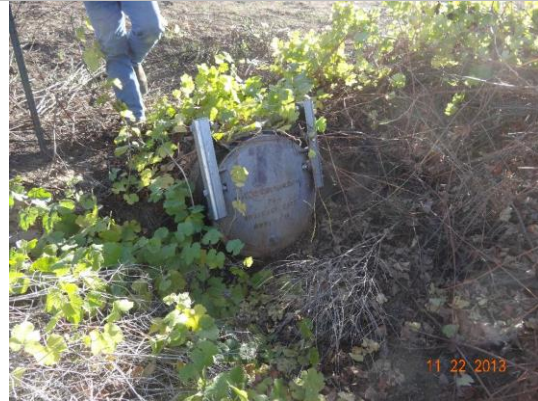
Photo 3 of 3 : UCIP_SP_2019_24821_44638.jpg

View of flap gate located on waterward side.

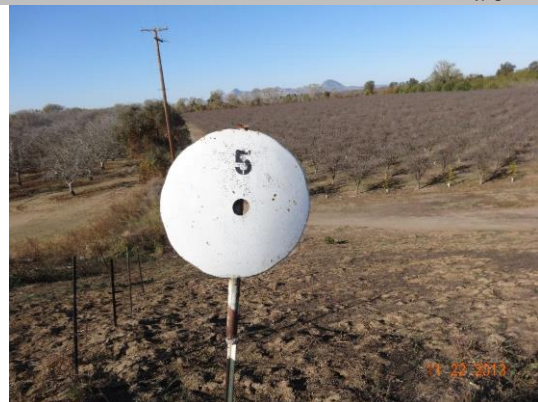
Photo 1 of 3 : UCIP_SP_2019_24822_44647.jpg

Marker visible on waterward side--No. 5.

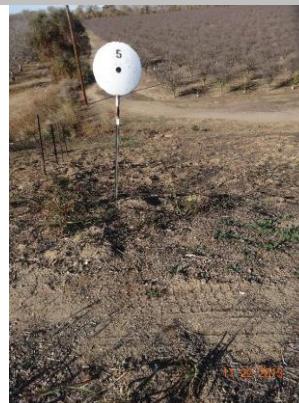
Photo 2 of 3 : UCIP_SP_2019_24822_44648.jpg

Overview of waterward slope--dense burrow activity on slope.

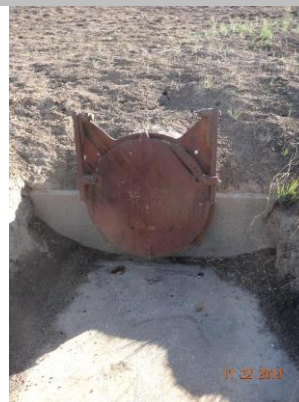
Photo 3 of 3 : UCIP_SP_2019_24822_44645.jpg

View of flap gate on waterward side.

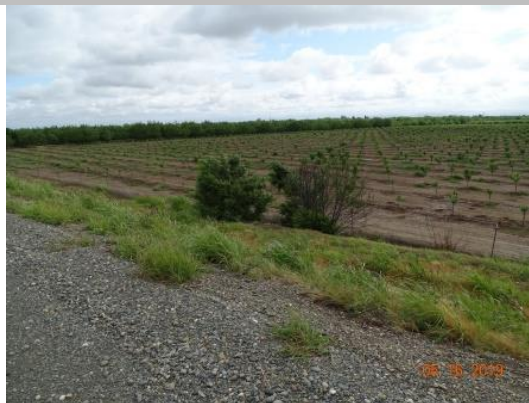
Photo 1 of 1 : SP_2019_RD0010_164_40_20190520_00102.jpg

LM Start	2.71	Rating **	M	Issue No.	40
LM End	2.71	Issue Type +	Ma	Location *	LS
Category	Earthen Levee			GPS Latitude/Longitude	
				Start	End
Item	Trim / Thin Trees			39.202609 °	39.202609 °
				-121.609395 °	-121.609395 °
DWR ID	DWR_RD0010_02_f_2018_40				
Comment Code					
T3 : Trim and thin trees to allow visibility of the ground and room to flood fight.					
Inspector Comment					
Trees less than 4" in diameter should be removed, Spring 2019.

View looking upstream landside of trees at levee toe that need to be removed, Spring 2019.

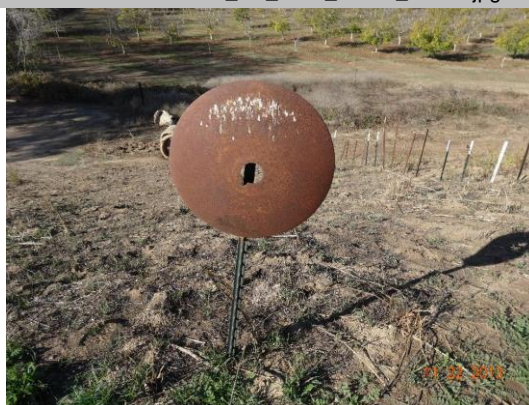
Photo 1 of 3 : UCIP_SP_2019_52889_44658.jpg

Comment Code					
Inspector Comment					
FS_ID:52889					
DS_ID:21284					
EP_NO: N/A					
Repair Type: Non-Urgent					
Crossing Status: Found					
UCIP Comments: 04/30/2013 Remove concrete piece preventing complete closure of screw gate on landward side. This crossing is referenced in the USACE Periodic Inspection as item USACE_CESPK_HON2_2013_p_0152. (DWR UCIP - O. Magana)					
FIELD_STRUCT_DESC: 36-inch corrugated metal gravity drainage pipe through the levee, 24 feet below the crown. Corrugated metal cutoff wall around the pipe at each shoulder. Flap gate on the waterside (WS) end. Slide gate on the landside (LS) end. Concrete headwall at each end.					
[Additional Reference(s): DWR Levee Log, 2005. USACE Sacramento O&M Manual 151, May 1953, (Station 259+76)].					
FS Date: 4/30/2013

Marker visible on waterward side.

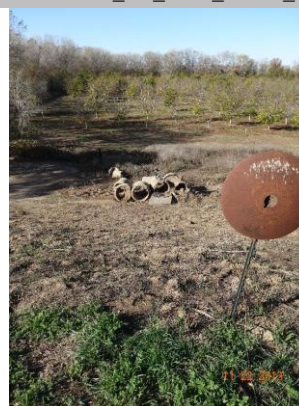
Photo 2 of 3 : UCIP_SP_2019_52889_44657.jpg

Overview of waterward slope--barrier placed at toe to discourage damage to crossing.

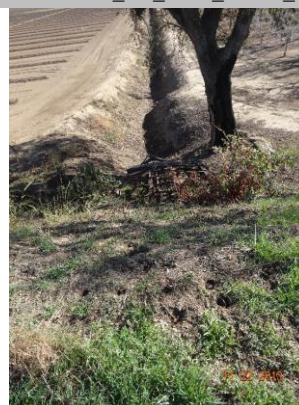
Photo 3 of 3 : UCIP_SP_2019_52889_44656.jpg

View of landward side--barrier used to discourage damage to crossing near toe.

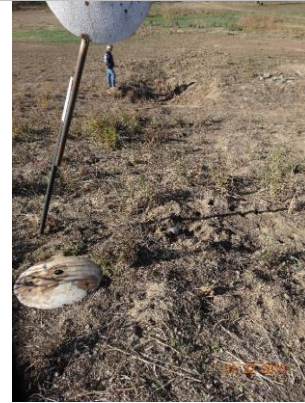
Photo 1 of 1 : SP_2019_RD0010_164_7_20190305_00001.jpg

LM Start	3.60	Rating **	M	Issue No.	7
LM End	3.60	Issue Type +	Ma	Location *	WS
Category	Earthen Levee			GPS Latitude/Longitude	
				Start	End
Item	Animal Control			39.215338 °	39.215338 °
				-121.610751 °	-121.610751 °
DWR ID	DWR_RD0010_02_s_2016_7				
Comment Code					
A3 : No rodents visible, but rodent burrows visible; need to backfill and compact or grout burrows.					
Inspector Comment					
There is no rodent activity, but the holes need to be properly backfilled, Spring 2019.

View of waterward slope--burrow activity present.

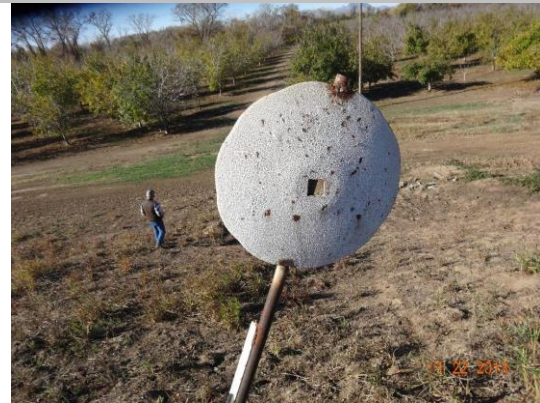
Photo 1 of 3 : UCIP_SP_2019_24825_44664.jpg

Comment Code						
Inspector Comment						
FS_ID:24825 DS_ID:21285 EP_NO: N/A Repair Type: Non-Urgent Crossing Status: Found UCIP Comments: 04/30/2013 Sediment blocking flap gate and screw gate--recommend removing material. Dense burrow activity present along levee slopes (large holes visible on landward side)--recommend addressing issue. This crossing is referenced in the USACE Periodic Inspection as item USACE_CESPK_HON2_2013_p_0169. (DWR UCIP - O. Magana) FIELD_STRUCT_DESC: 30-inch corrugated metal gravity drainage pipe through the levee, 19.5 feet below the crown. Corrugated metal cutoff wall around the pipe at each shoulder. Flap gate on the waterside (WS) end. Slide gate on the landside (LS) end. Concrete headwall at each end. [Additional Reference(s): DWR Levee Log, 2005. USACE Sacramento O&M Manual 151, May 1953, (Station 277+00)]. FS Date: 4/30/2013

Marker visible on waterward side.

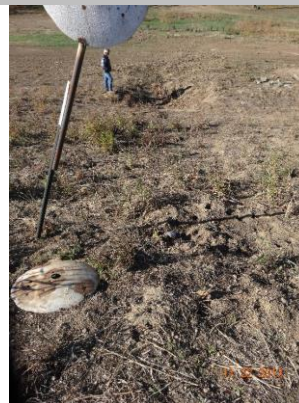
Photo 2 of 3 : UCIP_SP_2019_24825_44663.jpg

View of waterward slope--burrow activity present.

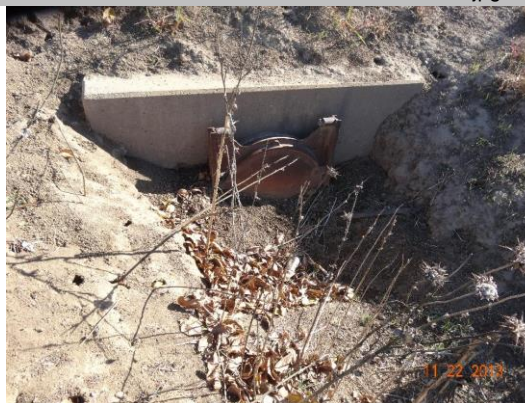
Photo 3 of 3 : UCIP_SP_2019_24825_44662.jpg

Flap gate located on waterward side--debris blocking gate.

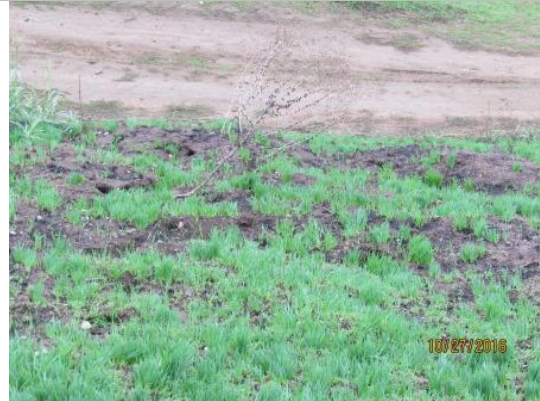
Photo 1 of 1 : SP_2019_RD0010_164_68_20190305_00023.jpg

LM Start	3.65	Rating **	M	Issue No.	68
LM End	3.65	Issue Type +	Ma	Location *	WS
Category	Earthen Levee			GPS Latitude/Longitude	
				Start	End
Item	Animal Control			39.216059 °	39.216059 °
				-121.610815 °	-121.610815 °
DWR ID	DWR_RD0010_02_f _ 2013_68				
Comment Code					
A3 : No rodents visible, but rodent burrows visible; need to backfill and compact or grout burrows.					
Inspector Comment					
No rodent activity but holes need to be properly backfilled, Spring 2019.

View of rodent holes on waterside slope, no evidence of rodent activity.

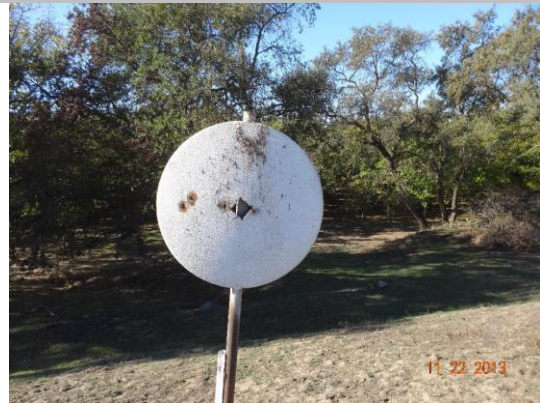
Photo 1 of 3 : UCIP_SP_2019_24826_44669.jpg

Comment Code						
Inspector Comment						
FS_ID:24826 DS_ID:21286 EP_NO: N/A Repair Type: Non-Urgent Crossing Status: Found UCIP Comments: 04/30/2013 Deformation observed on the top wall of pipe at the entrance of landward side--need to contact owner to address issue. This crossing is referenced in the USACE Periodic Inspection as item USACE_CESPK_HON2_2013_p_0180. (DWR UCIP - O. Magana) FIELD_STRUCT_DESC: 30-inch corrugated metal gravity drainage pipe through the levee, 21.5 feet below the crown. Corrugated metal cutoff walls around the pipe at each shoulder. Flap gate on the waterside (WS) end. Slide gate on the landside (LS) end. Concrete headwall at each end. [Additional Reference(s): DWR Levee Log, 2005. USACE Sacramento O&M Manual 151, May 1953, (Station 294+84)]. FS Date: 4/30/2013

View of marker located on waterward shoulder, no reference number is visible.

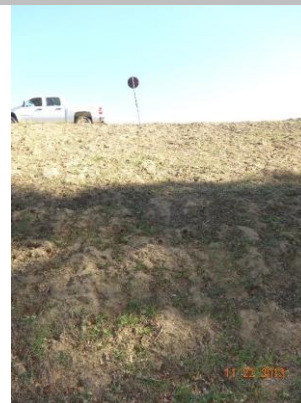
Photo 2 of 3 : UCIP_SP_2019_24826_44668.jpg

Comment Code						
Inspector Comment						
FS_ID:24826						
DS_ID:21286						
EP_NO: N/A						
Repair Type: Non-Urgent						
Crossing Status: Found						
UCIP Comments: 04/30/2013 Deformation observed on the top wall of pipe at the entrance of landward side--need to contact owner to address issue. This crossing is referenced in the USACE Periodic Inspection as item USACE_CESPK_HON2_2013_p_0180. (DWR UCIP - O. Magana)						
FIELD_STRUCT_DESC: 30-inch corrugated metal gravity drainage pipe through the levee, 21.5 feet below the crown. Corrugated metal cutoff walls around the pipe at each shoulder. Flap gate on the waterside (WS) end. Slide gate on the landside (LS) end. Concrete headwall at each end. [Additional Reference(s): DWR Levee Log, 2005. USACE Sacramento O&M Manual 151, May 1953, (Station 294+84)].						
FS Date: 4/30/2013

View of waterward slope.

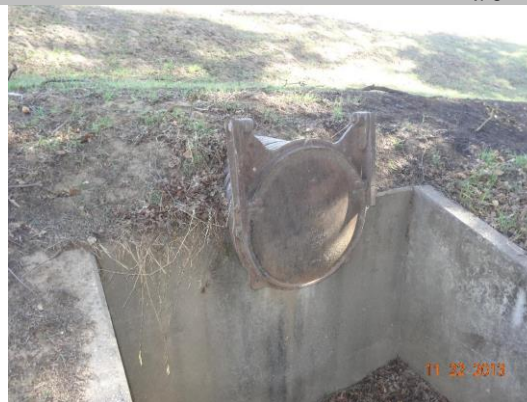
Photo 3 of 3 : UCIP_SP_2019_24826_44673.jpg

View of flapgate on concrete head wall on waterward side.

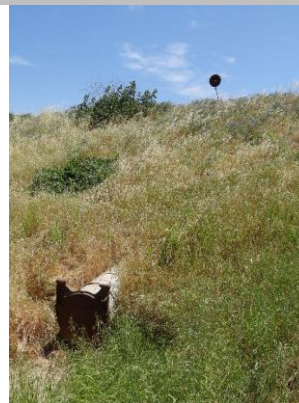
Photo 1 of 3 : UCIP_SP_2019_24751_44375.jpg

Comment Code					
Inspector Comment					
FS_ID:24751 DS_ID:21288 EP_NO: N/A Repair Type: Non-Urgent Crossing Status: Found UCIP Comments: 04/30/2013 Need to updated photos showing cleared slopes. This crossing is referenced in the USACE Periodic Inspection as item USACE_CESPK_HON2_2013_p_0193. (DWR UCIP - O. Magana) FIELD_STRUCT_DESC: 24-inch corrugated metal gravity drainage pipe through the levee, 19 feet below the crown. Corrugated metal cutoff wall around the pipe at each shoulder. Flap gate on the waterside (WS) end. Slide gate on the landside (LS). Concrete headwall, saddle, and apron on the WS end. [Additional Reference(s): DWR Levee Log, 2005. USACE Sacramento O&M Manual 151, May 1953, (Station 322+25)]. FS Date: 4/30/2013

View of waterward side--dense vegetation on slope.

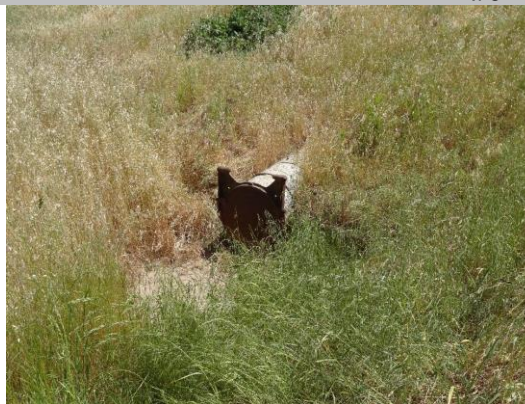
Photo 2 of 3 : UCIP_SP_2019_24751_44376.jpg

View of flap gate on waterward side.

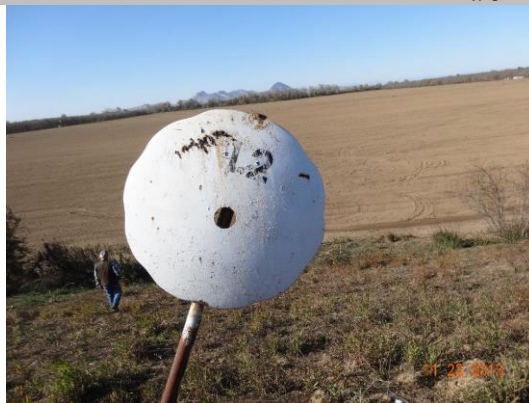
Photo 1 of 3 : UCIP_SP_2019_24828_44680.jpg

View of marker located on waterward shoulder--crossing referenced as No. 12.

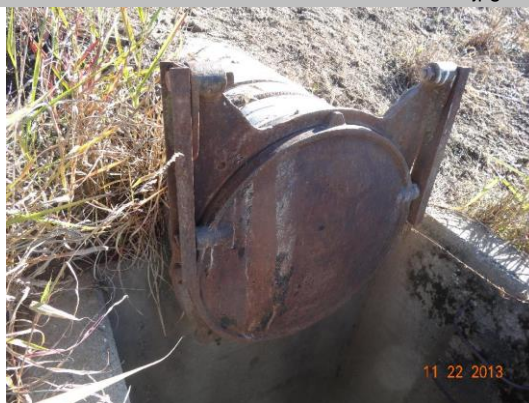
Photo 2 of 3 : UCIP_SP_2019_24828_44684.jpg

View of flap gate located on waterward side.

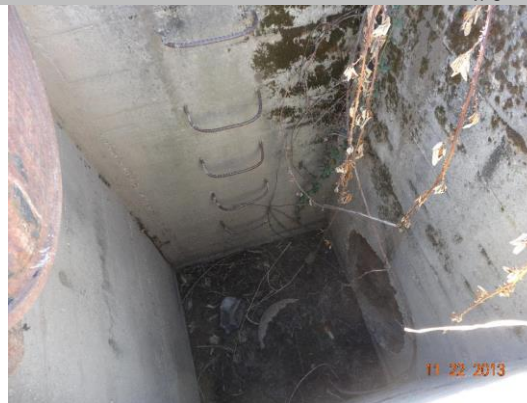
Photo 3 of 3 : UCIP_SP_2019_24828_44683.jpg

Inside view of concrete distribution box.

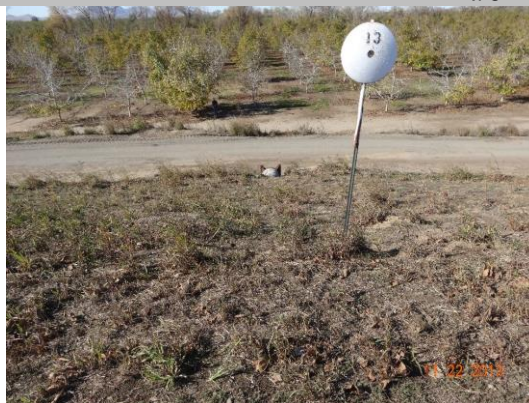
Photo 1 of 3 : UCIP_SP_2019_27793_51514.jpg

Comment Code					
Inspector Comment					
FS_ID:27793 DS_ID:21291 EP_NO: N/A Repair Type: Non-Urgent Crossing Status: Found UCIP Comments: 04/30/2013 Need to contact owner to remove debris inside concrete distribution box and on slope. This crossing is referenced in the USACE Periodic Inspection as item USACE_CESPK_HON2_2013_p_0244. (DWR UCIP - O. Magana) FIELD_STRUCT_DESC: 30-inch corrugated metal gravity drainage pipe through the levee, 17.3 feet below the crown. Corrugated metal cutoff wall around the pipe at each shoulder. Flap gate on the waterside (WS) end. Slide gate on the landside (LS) end. Concrete headwall at each end. [Additional Reference(s): DWR Levee Log, 2005. USACE Sacramento O&M Manual 151, May 1953, (Station 413+81)]. FS Date: 4/30/2013

View of marker located on waterward shoulder, pipe is reference as No. 13.

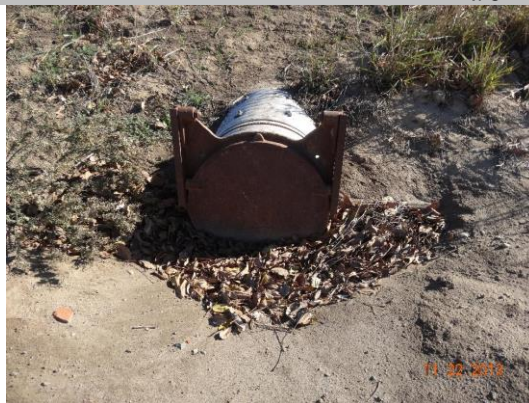
Photo 2 of 3 : UCIP_SP_2019_27793_51517.jpg

View of flap gate located on waterward side.

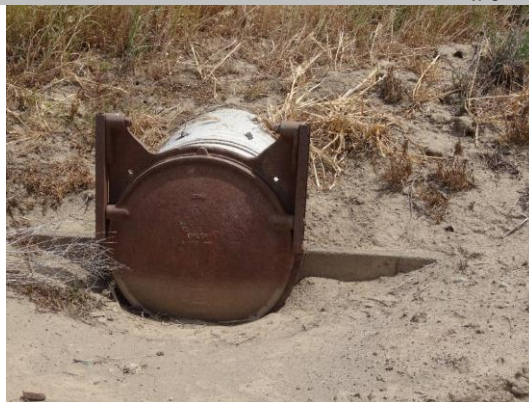
Photo 3 of 3 : UCIP_SP_2019_27793_51513.jpg

Flap gate and concrete headwall visible on waterward side.

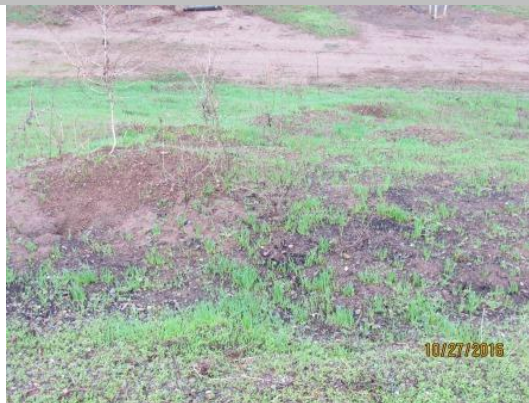
Photo 1 of 1 : SP_2019_RD0010_164_32_20190305_00008.jpg

LM Start	6.72	Rating **	M	Issue No.	32
LM End	6.72	Issue Type +	Ma	Location *	WS
Category	Earthen Levee			GPS Latitude/Longitude	
				Start	End
Item	Animal Control			39.257859 °	39.257859 °
				-121.617667 °	-121.617667 °
DWR ID	DWR_RD0010_02_f_2015_32				
Comment Code					
A3 : No rodents visible, but rodent burrows visible; need to backfill and compact or grout burrows.					
Inspector Comment					
No rodent activity but holes need to be properly backfilled, Spring 2019.

View of rodent holes on waterside levee slope.

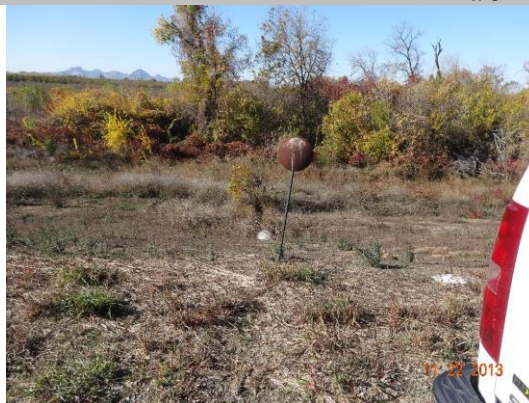
Photo 1 of 3 : UCIP_SP_2019_24831_44700.jpg

Visible marker located on waterward shoulder--no id number noted.

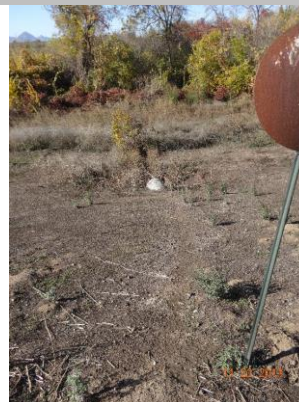
Photo 2 of 3 : UCIP_SP_2019_24831_44699.jpg

View of waterward slope.

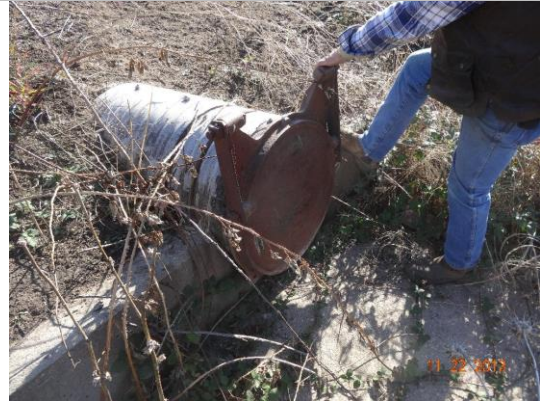
Photo 3 of 3 : UCIP_SP_2019_24831_44698.jpg

Flap gate visible on waterward side.

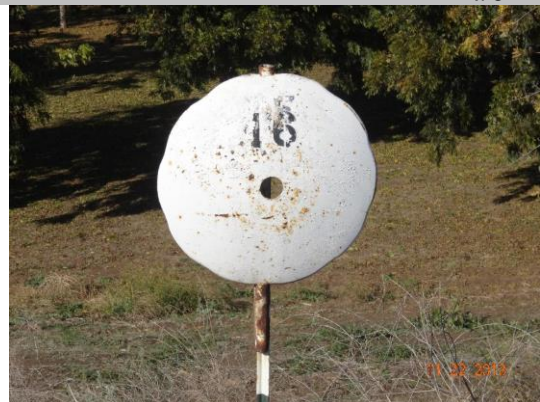
Photo 1 of 3 : UCIP_SP_2019_24832_44705.jpg

Marker visible on waterward shoulder, crossing is referenced as No. 16.

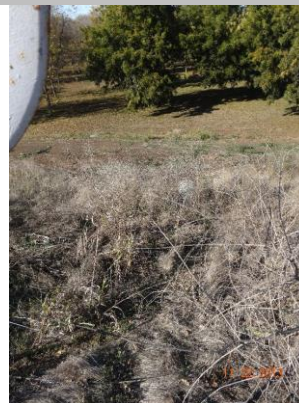
Photo 2 of 3 : UCIP_SP_2019_24832_44704.jpg

View of waterward side.

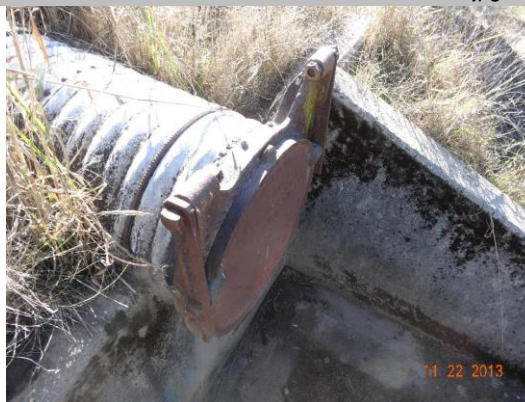
Photo 3 of 3 : UCIP_SP_2019_24832_44703.jpg

View of flap gate located on waterward side.

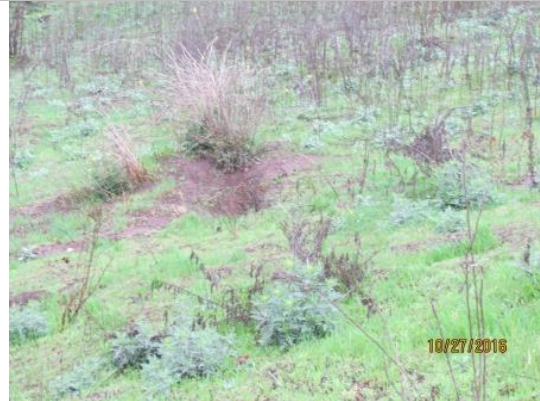
Photo 1 of 1 : SP_2019_RD0010_164_35_20190305_00012.jpg

LM Start	8.09	Rating **	M	Issue No.	35
LM End	8.09	Issue Type +	Ma	Location *	WS
Category	Earthen Levee			GPS Latitude/Longitude	
				Start	End
Item	Animal Control			39.275179 °	39.275179 °
				-121.611283 °	-121.611283 °
DWR ID	DWR_RD0010_02_f_2015_35				
Comment Code					
A3 : No rodents visible, but rodent burrows visible; need to backfill and compact or grout burrows.					
Inspector Comment					
No rodent activity but holes need to be backfilled, Spring 2019.

View of rodent hole on waterside.

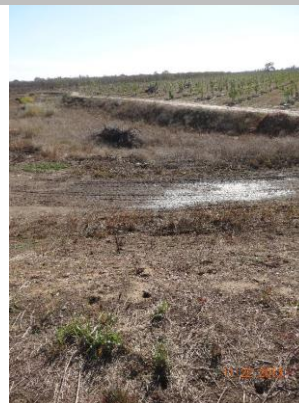
Photo 2 of 3 : UCIP_SP_2019_27775_51472.jpg

View of landward side.

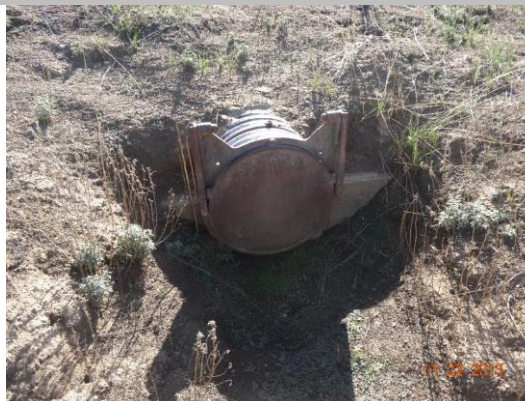
Photo 3 of 3 : UCIP_SP_2019_27775_51477.jpg

View of flap gate visible on waterward side.

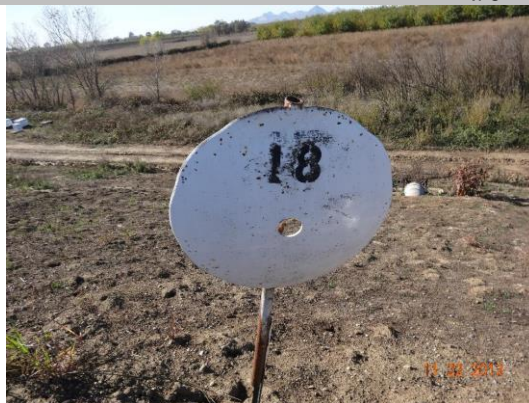
Photo 1 of 3 : UCIP_SP_2019_24834_44715.jpg

Comment Code					
Inspector Comment					
FS_ID:24834 DS_ID:21297 EP_NO: N/A Repair Type: Non-Urgent Crossing Status: Found UCIP Comments: 04/30/2013 Slide gate missing on landward side. Need to contact owner to determine status of crossing. This crossing is referenced in the USACE Periodic Inspection as item USACE_CESPK_HON2_2013_p_0367. (DWR UCIP - O. Magana) FIELD_STRUCT_DESC: 24-inch corrugated metal gravity drainage pipe through the levee, 14 feet below the crown. Corrugated metal cutoff wall around the pipe at each shoulder. Flap gate on the waterside (WS) end. Slide gate on the landside (LS), slide gate missing. Concrete headwall, saddle, and apron on the WS end. 6-foot by 6-foot concrete splash apron at the WS toe. [Additional Reference(s): DWR Levee Log, 2005. USACE Sacramento O&M Manual 151, May 1953, (Station 565+74)]. FS Date: 4/30/2013

Marker visible on waterward shoulder, crossing is referenced as No. 18.

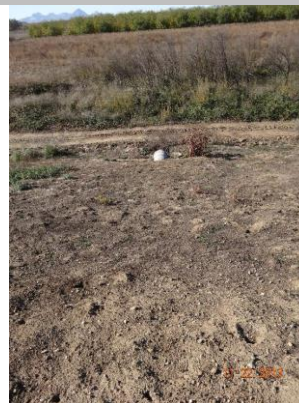
Photo 2 of 3 : UCIP_SP_2019_24834_44714.jpg

View of waterward side.

Comment Code						
Inspector Comment						
FS_ID:24834 DS_ID:21297 EP_NO: N/A Repair Type: Non-Urgent Crossing Status: Found UCIP Comments: 04/30/2013 Slide gate missing on landward side. Need to contact owner to determine status of crossing. This crossing is referenced in the USACE Periodic Inspection as item USACE_CESPK_HON2_2013_p_0367. (DWR UCIP - O. Magana) FIELD_STRUCT_DESC: 24-inch corrugated metal gravity drainage pipe through the levee, 14 feet below the crown. Corrugated metal cutoff wall around the pipe at each shoulder. Flap gate on the waterside (WS) end. Slide gate on the landside (LS), slide gate missing. Concrete headwall, saddle, and apron on the WS end. 6-foot by 6-foot concrete splash apron at the WS toe. [Additional Reference(s): DWR Levee Log, 2005. USACE Sacramento O&M Manual 151, May 1953, (Station 565+74)]. FS Date: 4/30/2013

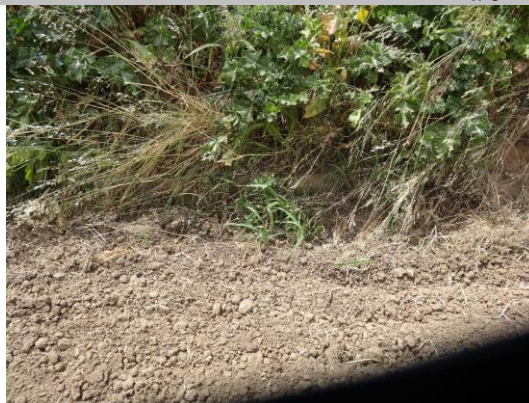
Photo 3 of 3 : UCIP_SP_2019_24768_44449.jpg

Comment Code						
Inspector Comment						
FS_ID:24768 DS_ID:21298 EP_NO: N/A Repair Type: Non-Urgent Crossing Status: Found UCIP Comments: 04/30/2013 Crossing is buried--found indicators of concrete headwall. Need to contact owner to determine status of crossing. This crossing is referenced in the USACE Periodic Inspection as item USACE_CESPK_HON2_2013_p_0378. (DWR UCIP - O. Magana) FIELD_STRUCT_DESC: 24-inch corrugated metal gravity drainage pipe through the levee, 13 feet below the crown. Corrugated metal cutoff wall around the pipe at each shoulder. Flap gate on the waterside (WS) end. Slide gate on the landside (LS) end. Concrete headwall at each end. Metal marker on the WS slope. [Additional Reference(s): DWR Levee Log, 2005. USACE Sacramento O&M Manual 151, May 1953, (Station 576+75)]. FS Date: 4/30/2013

View of concrete headwall visible through dense vegetation.

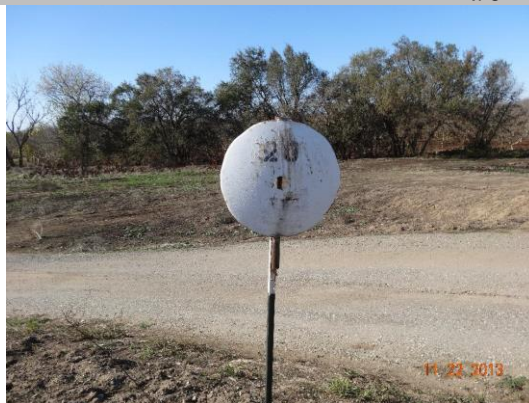
Photo 1 of 3 : UCIP_SP_2019_24769_44454.jpg

Comment Code					
Inspector Comment					
FS_ID:24769 DS_ID:21299 EP_NO: N/A Repair Type: Non-Urgent Crossing Status: Found UCIP Comments: 04/30/2013 Need to contact owner. Need to clear debris from concrete distribution box on waterward and remove debris blocking landward side.This crossing is referenced in the USACE Periodic Inspection as item USACE_CESPK_HON2_2013_p_0383. (DWR UCIP - O. Magana) FIELD_STRUCT_DESC: 24-inch corrugated metal gravity drainage pipe through the levee, 12 feet below the crown. Corrugated metal cutoff wall around the pipe at each shoulder. Flap gate on the waterside (WS) end. Slide gate on the landside (LS). Concrete headwall, saddle, and apron on the WS end. Metal marker on the WS shoulder. [Additional Reference(s): DWR Levee Log, 2005. USACE Sacramento O&M Manual 151, May 1953, (Station 582+72)]. FS Date: 4/30/2013

Marker visible on waterward side shoulder, crossing is referenced as No. 20.

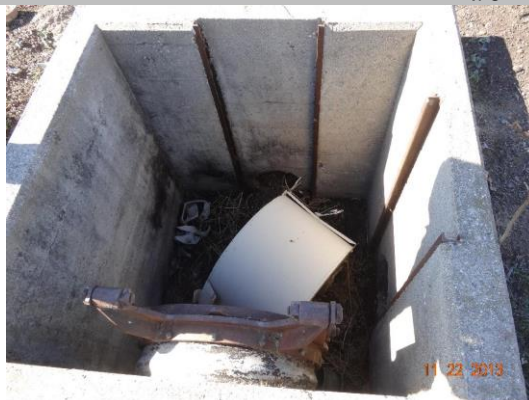
Photo 3 of 3 : UCIP_SP_2019_24769_44452.jpg

Comment Code						
Inspector Comment						
FS_ID:24769 DS_ID:21299 EP_NO: N/A Repair Type: Non-Urgent Crossing Status: Found UCIP Comments: 04/30/2013 Need to contact owner. Need to clear debris from concrete distribution box on waterward and remove debris blocking landward side.This crossing is referenced in the USACE Periodic Inspection as item USACE_CESPK_HON2_2013_p_0383. (DWR UCIP - O. Magana) FIELD_STRUCT_DESC: 24-inch corrugated metal gravity drainage pipe through the levee, 12 feet below the crown. Corrugated metal cutoff wall around the pipe at each shoulder. Flap gate on the waterside (WS) end. Slide gate on the landside (LS). Concrete headwall, saddle, and apron on the WS end. Metal marker on the WS shoulder. [Additional Reference(s): DWR Levee Log, 2005. USACE Sacramento O&M Manual 151, May 1953, (Station 582+72)]. FS Date: 4/30/2013

View of concrete distribution box located on waterward side.

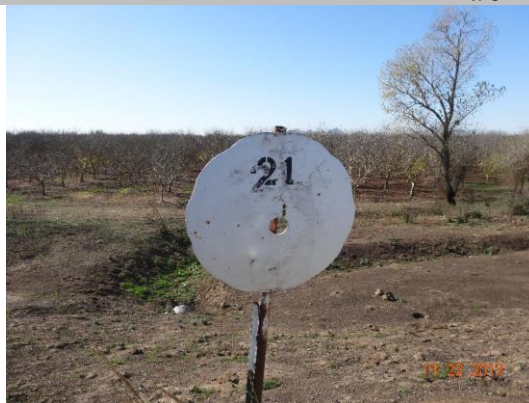
Photo 1 of 3 : UCIP_SP_2019_24835_44721.jpg

Marker visible on waterward shoulder, crossing referenced as No. 21.

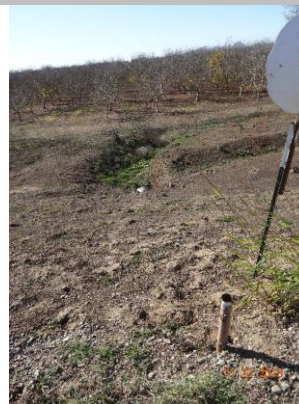
Photo 2 of 3 : UCIP_SP_2019_24835_44720.jpg

View of waterward side.

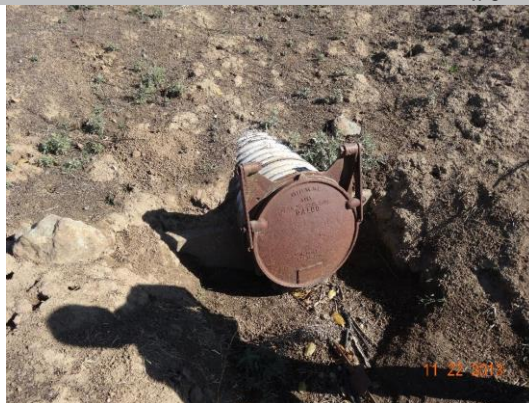
Photo 3 of 3 : UCIP_SP_2019_24835_44725.jpg

View of flap gate located on waterward side.

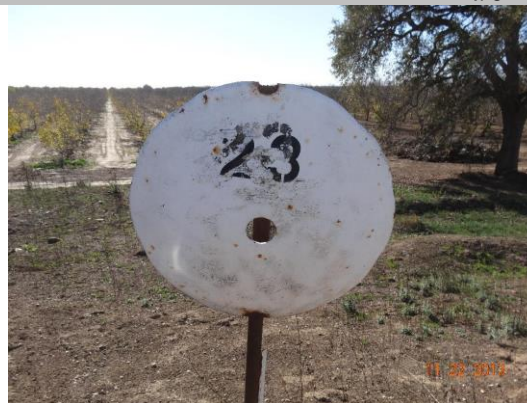
Photo 1 of 3 : UCIP_SP_2019_24837_44731.jpg

Marker visible on waterward shoulder, crossing is referenced as No. 23.

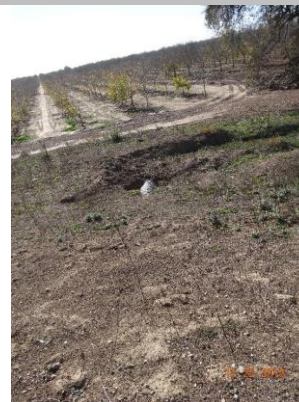
Photo 2 of 3 : UCIP_SP_2019_24837_44735.jpg

Overview of waterward side.

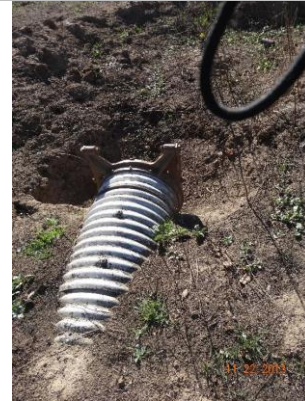
Photo 3 of 3 : UCIP_SP_2019_24837_44734.jpg

Pipe through waterward side.
